# **Micrometeoroid and Orbital Debris Impact Inspection of the HST WFPC2 Radiator**

**J.-C. Liou and the HST WFPC2 MMOD  
Inspection Team**

- **Conduct micrometeoroid and orbital debris (MMOD) impact inspection of the Hubble Space Telescope (HST) Wide Field Planetary Camera 2 (WFPC2) radiator**
  - Document the physical characteristics of large ( $\geq 300 \mu\text{m}$ ) impact features
    - Locations and distribution
    - Crater shape, size, depth, volume
  - Extract residues from craters for compositional analysis
  - Perform hypervelocity impact tests for data interpretation
- **Use the data to validate or improve the near-Earth MMOD environment definition**
  - Flux
  - Orbital debris versus meteoroids
  - Time history (limited)

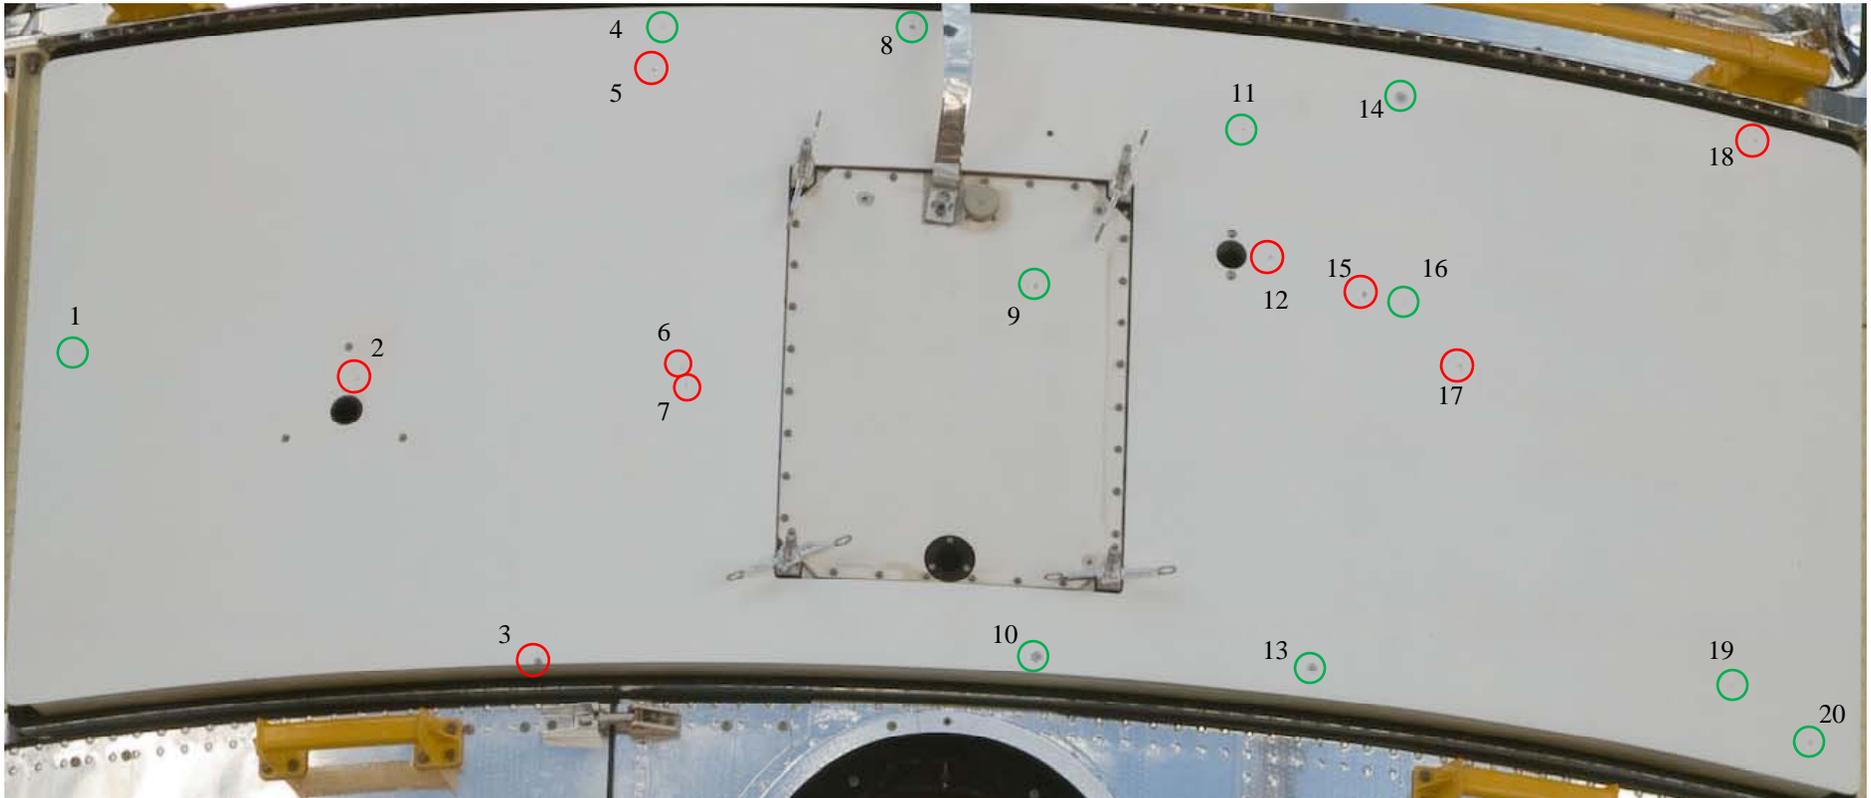
S125e006995.jpg (edited)

- Red circles: Impacts identified from SM3B images (2002)
- Green circles: Impacts identified from SM4 images (2009)

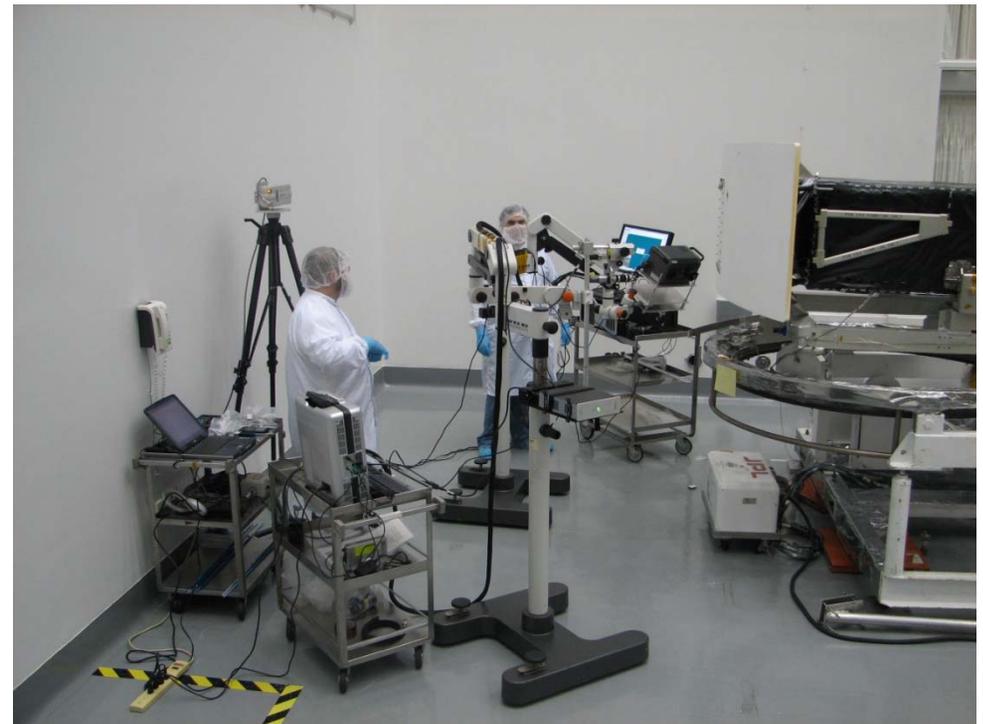
# MMOD Inspection at NASA Goddard

- **WFPC2 was shipped to Goddard in late June 2009**
- **MMOD inspection: 6-17 July, 24 August – 4 September, and 14-25 September 2009**
  - **Major inspection instruments: LAP CAD-Pro laser template projector and VHX-600 digital microscope**

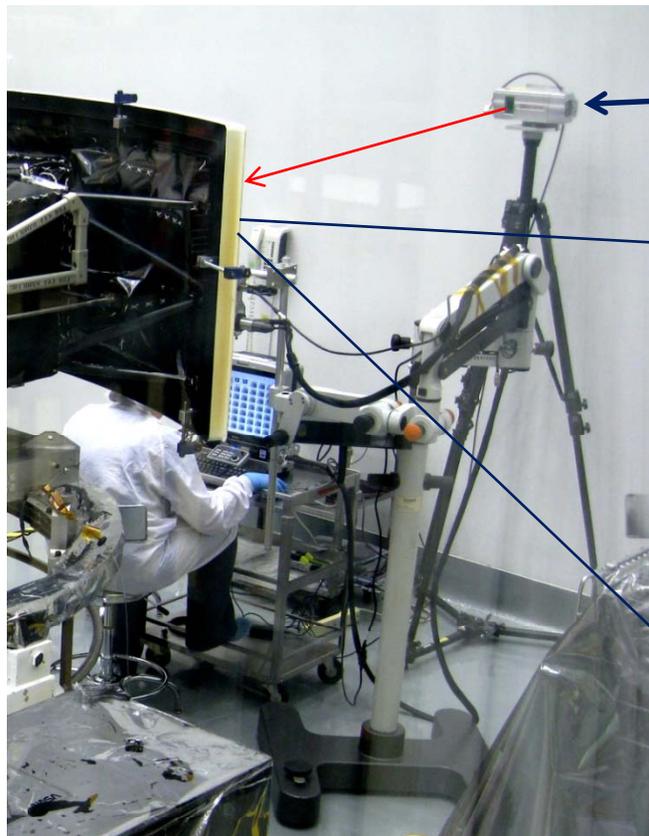
Cleanroom setup

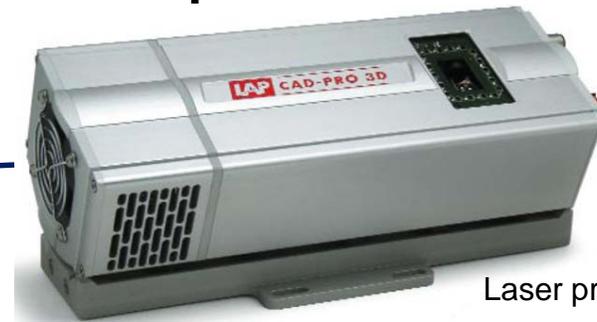
Laser projector head

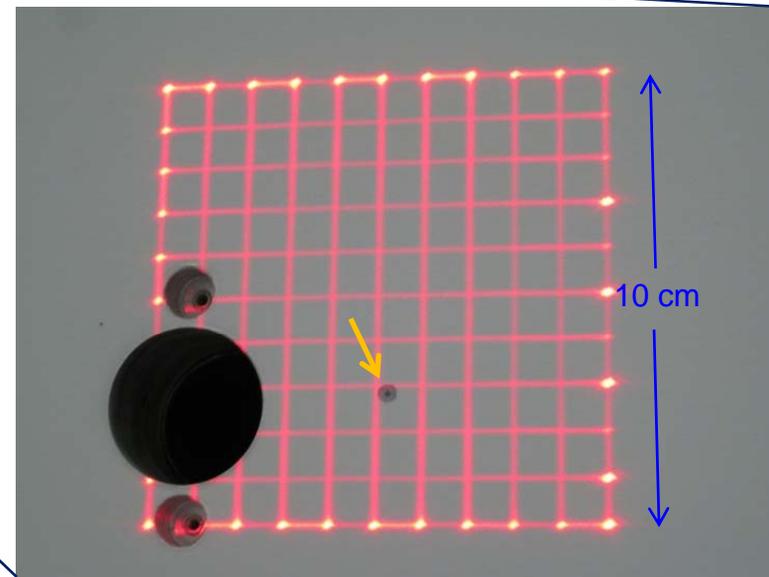
Square grid projected on a curved surface

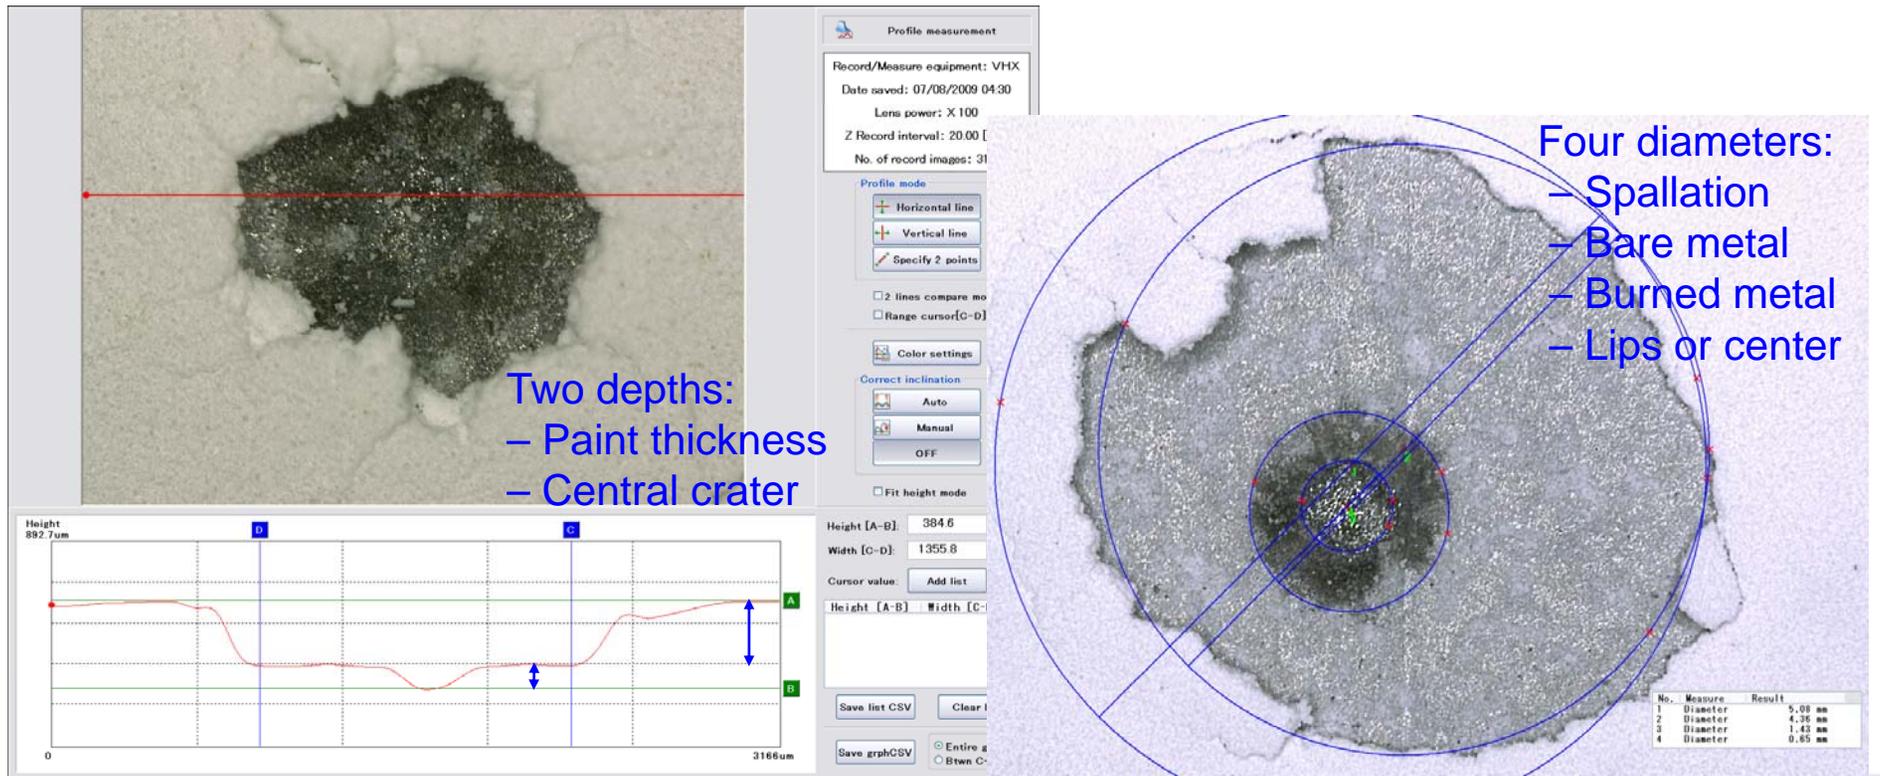
- Documented 685 impact craters ( $\geq 300 \mu\text{m}$ ) and numerous non-impact features
- No through-hole
- The largest one: 1.6 mm crater plus 1.4 cm spall zone

Two depths:  
 - Paint thickness  
 - Central crater

Four diameters:  
 - Spallation  
 - Bare metal  
 - Burned metal  
 - Lips or center

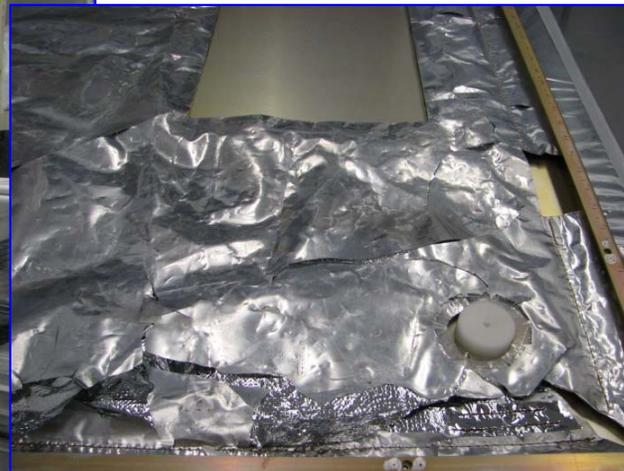
# Bay 5 Multi-Layer Insulation (MLI) Inspection

- **The HST Bay 5 MLI was shipped to JSC for 5-week MMOD inspection on 2 Feb 2010**
  - Bay 5 MLI was in space between 1990 and 2009
  - Dimensions of MLI: 1.1 m × 1.5 m (with several cut-out areas)
  - Consists of 17 layers
    - The outermost layer: 127 μm thick FEP (fluorinated ethylene-propylene) Teflon with vapor deposited Al (VDA) coated on the backside
  - Document impact features as small as ~100 μm

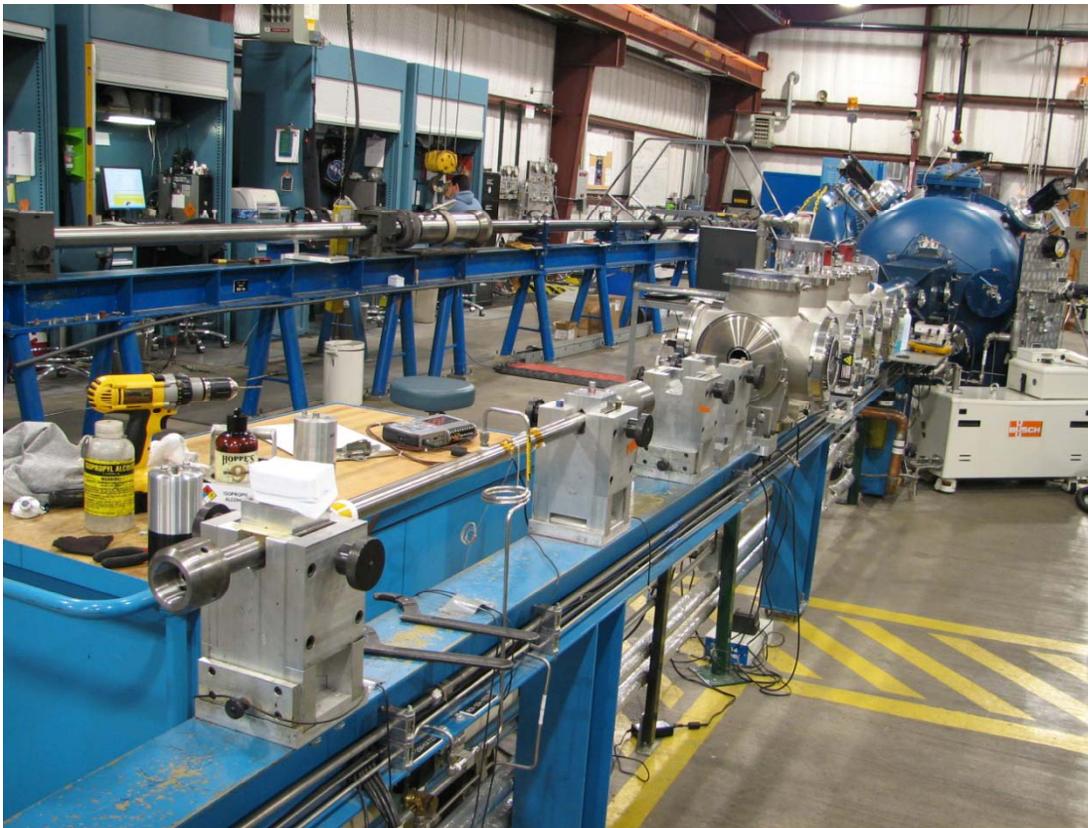
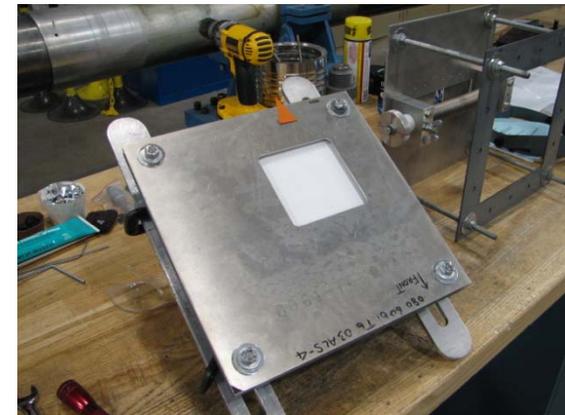
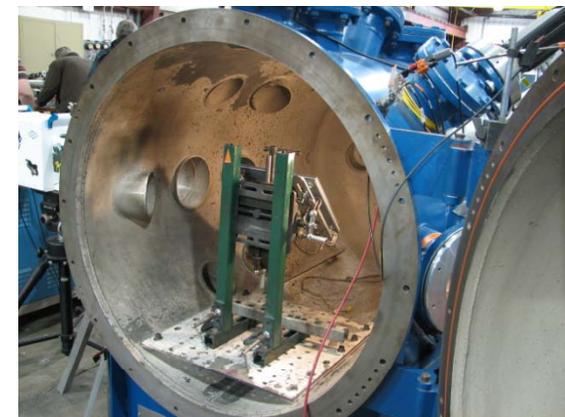
- **60 shots scheduled for projectiles of different sizes, materials, impact speed, and impact angle**
  - Started on 17 Feb 2010

.17 caliber 2-stage light gas gun at JSC White Sands Test Facility
